Power through residential & industrial Albany for VECTOR Ltd

Newsletter May 2006

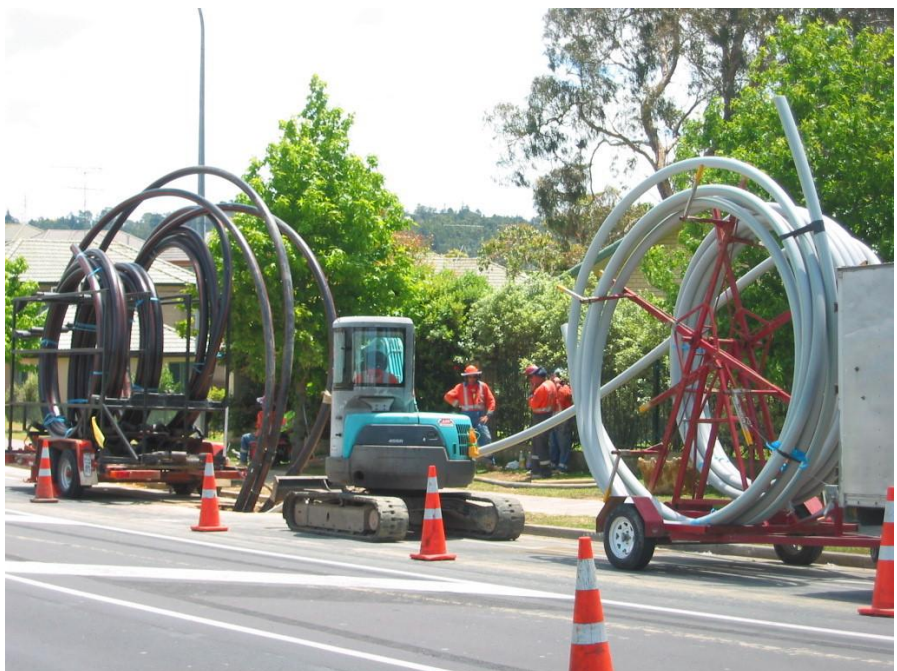
Launching the 4-way power/communication ducts into the drilled hole.

Along with the acceptance of using the slightly undersized continuous ducting for the 33kV power cabling, it was proposed that the three ducts and the single 110mm communications duct be installed into a single 350mm diameter borehole in õquad-foiõ arrangement.

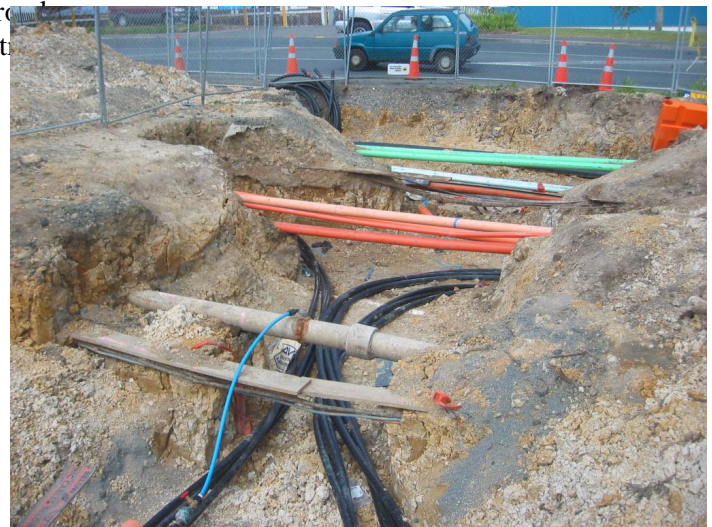
Intensity of existing underground services

By far the biggest hurdle on the project was locating existing underground services. For a relatively new area of Auckland the quality of records of underground services was poor.

The ambiguous nature of many power plans made it necessary to cut into existing live power ducts to determine their content. Cables were encountered that were not marked on any plan and some existing services were installed through existing buried council services. A complete lack of quality control for existing underground services installation and location in this area became quickly apparent. Due to this we were forced to utilise ground penetrating radar.

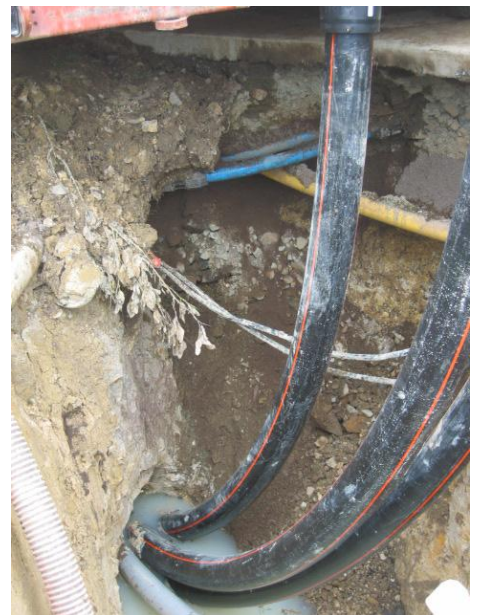
4-way duct installation
drawn into drilled tunnel

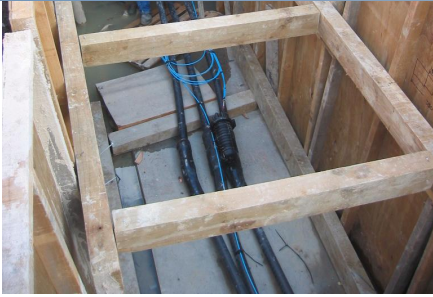
Excavation and shoring of the
cable joint pits
