a Dairy Factory. Drains call for emergency work.

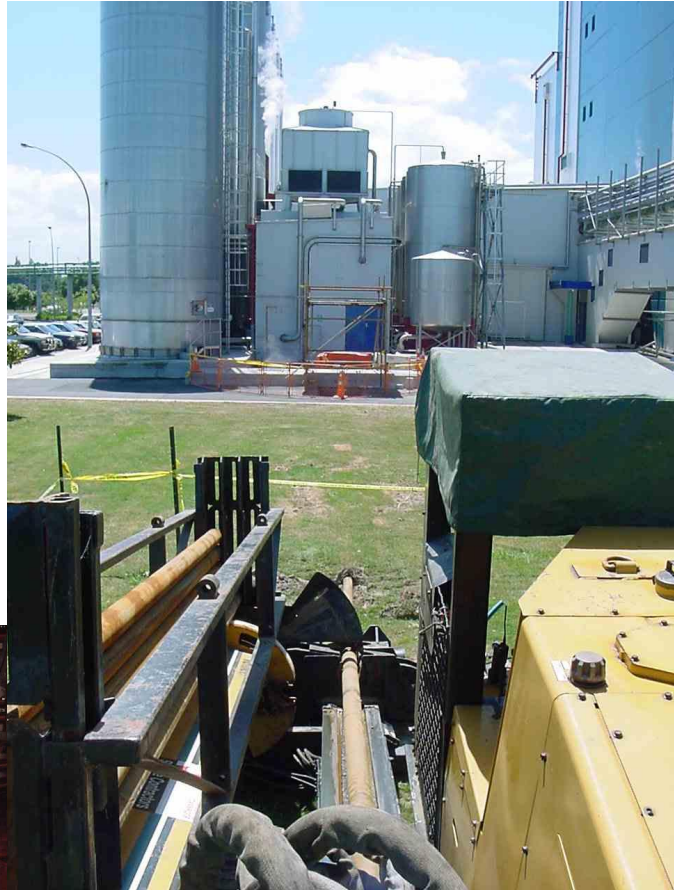
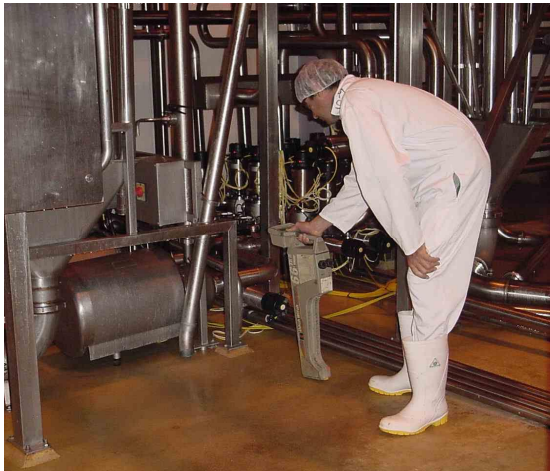
The steel reinforcing in-bedded in the floor slab coupled with the surrounding electric motors and steel pipe-work made electronically locating the pilot drill under the building difficult. To overcome this Smythe Contractors utilised special low pulsing location equipment imported for a previous under floor project.

Locating the pilot drill in the sterile environment.

The ground under the floor slab was saturated and it was difficult to maintain the required grade. Due to this saturation it was decided not to pre-ream and the pipe was connected to the back of the reamer and pulled back in one operation. The pipe was cleaned out and the dropper connections made. The emergency works were completed within four weeks with no factory shutdowns required.
